Rev 1: September 2018
FSN Ref: 484380 FSCA Ref: 484380

Date: 06/06/2025

Urgent Field Safety Notice

VARIOUS BVM RESUSCITATORS

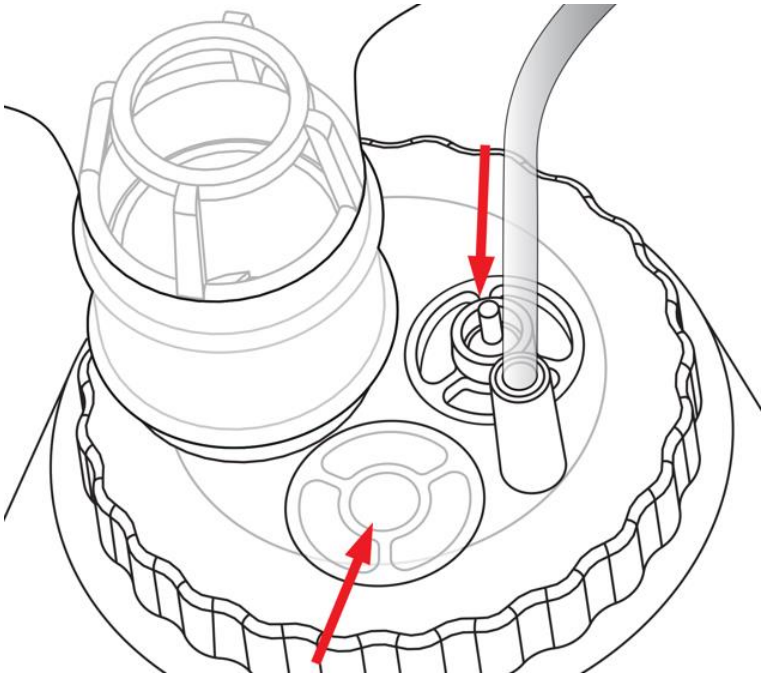
2. Reason for Field Safety Corrective Action (FSCA)*
2.	1. Description of the product problem*
	Some devices have been identified during pre-use checks as missing one of the valves at the rear of the BVM Resuscitator, position as shown below.

2.	2. Hazard giving rise to the FSCA*
	If the BVM has been supplied without the one valve that controls entrainment of atmospheric air, which would result in dilution of Oxygen concentration and reduction of delivered FiO2. This does not have an impact upon the ability to provide adequate ventilation but does have an impact upon the ability to deliver the higher Oxygen concentrations as detailed in the product instructions for use. This may result in negative impact upon clinical outcome during CPR.

2.	5. Further information to help characterise the problem N/A	
2.	6. Background on Issue Following a customer report from the market and subsequent thorough inspection and analysis of internal stock, we have identified that some products have been manufactured without one of the valves at the rear of the BVM Resuscitator.

2.	7. Other information relevant to FSCA N/A	
	3. Type of Action to mitigate the risk*	
3.	**1. Action To Be Taken by the User*** ☒ Identify Device ☒ Quarantine Device ☐ Return Device ☐ Destroy Device ☐ On-site device modification/inspection ☐ Follow patient management recommendations ☒ Take note of amendment/reinforcement of Instructions For Use (IFU) ☒ Other ☐ None Please distribute this Field Safety Notice to all potential users of the BVM Resuscitators listed above, within your facility. This is for their awareness of the potential problem and to carry out the following actions. To ensure the safety of patients we recommend the following actions. 1. Identify any potentially affected products from the affected codes and lot numbers listed above. 2. All users must perform a thorough visual inspection before use of the products and lot numbers listed above, to confirm both one-way valves are present. 3. Retain any affected sample(s) identified, and please report to us immediately. **Please note**: This is not a product removal. Please complete and return the Reply Form provided to priority@intersurgical.co.uk, to confirm receipt of this notice and that the necessary actions are being taken. Please continue to report to Intersurgical any adverse events involving this product.
